Re: Rogers Lake 2020 Invasive Aquatic Plant Species Survey

Figure 1
2020 Survey Tracks
and Water Sampling

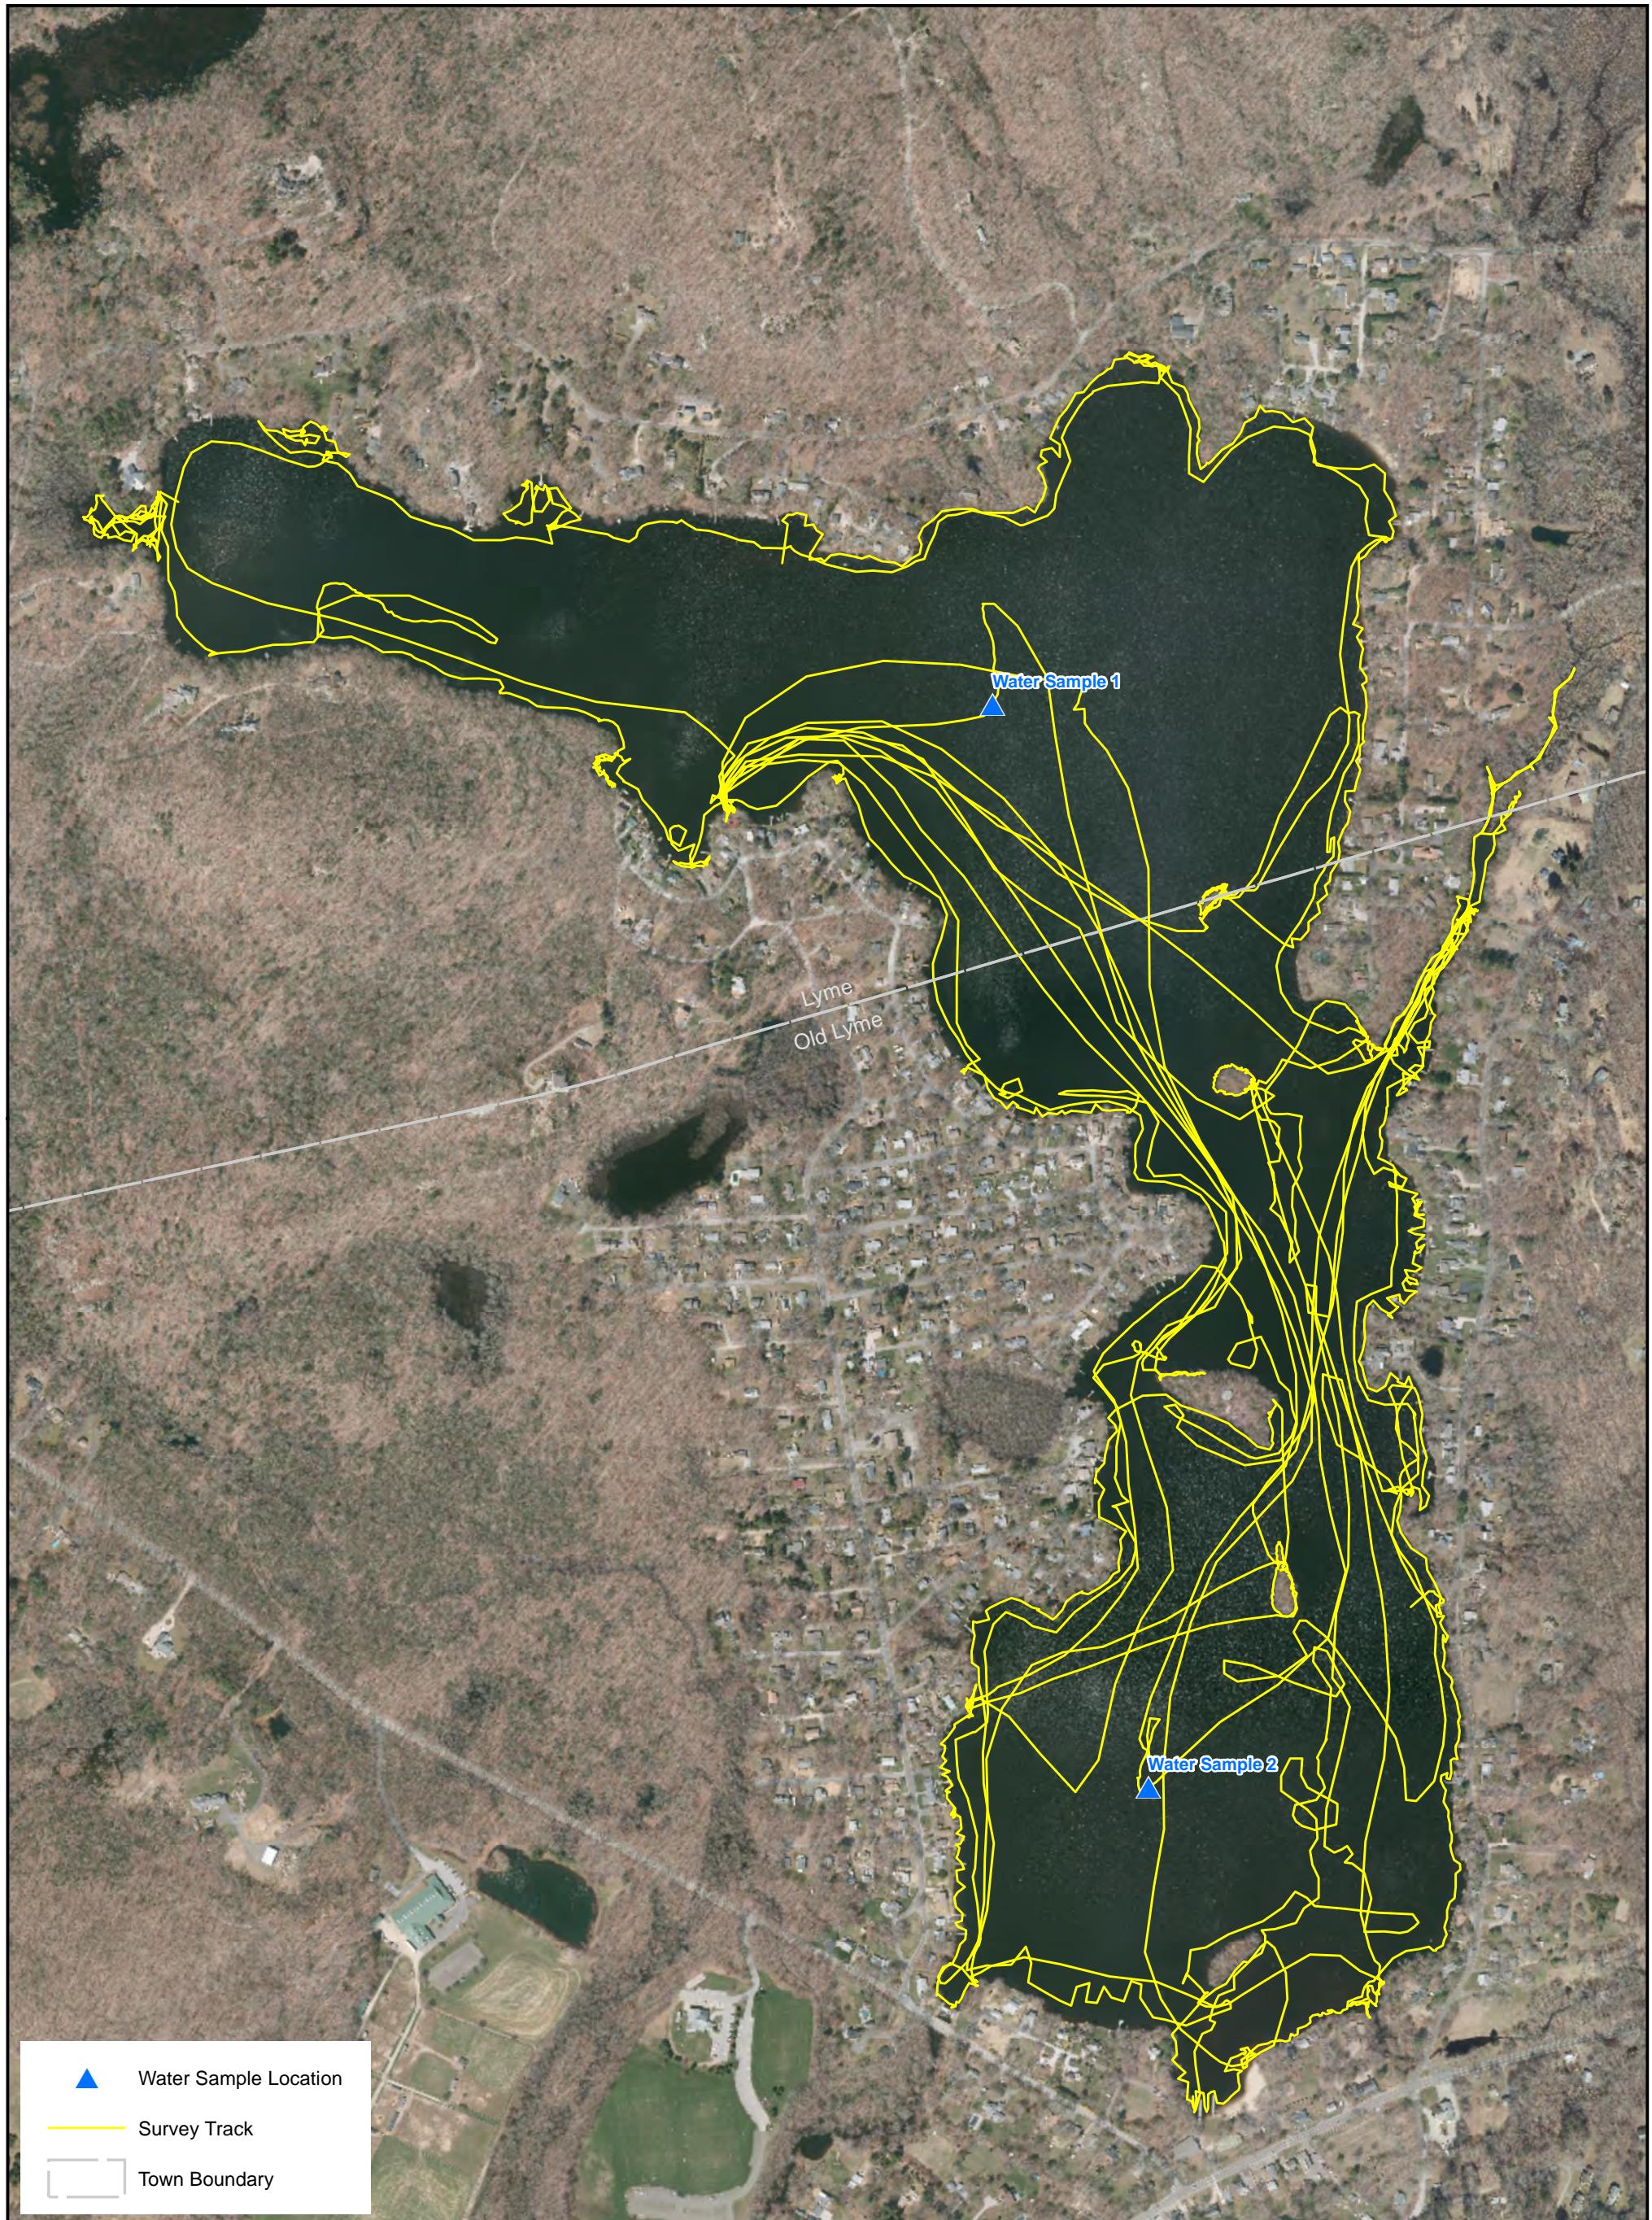
SWCA Senior Ecologist Dr. Steve Johnson led five days of aquatic plant surveys on June 23, 24, 25, 30 and July 1 within Rogers Lake in Old Lyme/Lyme, Connecticut. The primary objective of the survey was to determine the current status and distribution of aquatic invasive species within Rogers Lake. SWCA focused survey efforts in shallow-water areas where sunlight was likely to reach the lake bottom (up to 10 feet in depth), but did make passes into deeper waters as well (Figure 1). Most of our survey efforts were located in areas shallow enough to support dense aquatic vegetation which are found around the perimeter of the lake and islands. In general, SWCA observed a dramatic reduction in invasive species throughout Rogers Lake. The reduction in the density of invasive plants has made the general sampling methodology followed by All Habitat Services, LLC (All Habitat) in 2014 less efficient. In many cases, even when a patch of invasive plants was visible, it took numerous tosses of the grapple hook to collect a specimen. Therefore, SWCA relied primarily on visual searches for submerged invasive aquatic species, as random sampling would likely provide numerous false negative results. For observed or suspected invasive plants in water too deep to identify to species from the surface, SWCA utilized a grappling hook attached to approximately 5 meters of rope to obtain a specimen.

SWCA mapped observed invasive aquatic plant locations using a tablet with GPS capabilities, allowing us to create polygons and polylines to depict larger patches of invasive species. A waterproof handheld Garmin etrex 20 GPS unit was used in areas too shallow to reach with a motorboat. In these areas, kayaks were deployed to reach the extent of the invasive species.

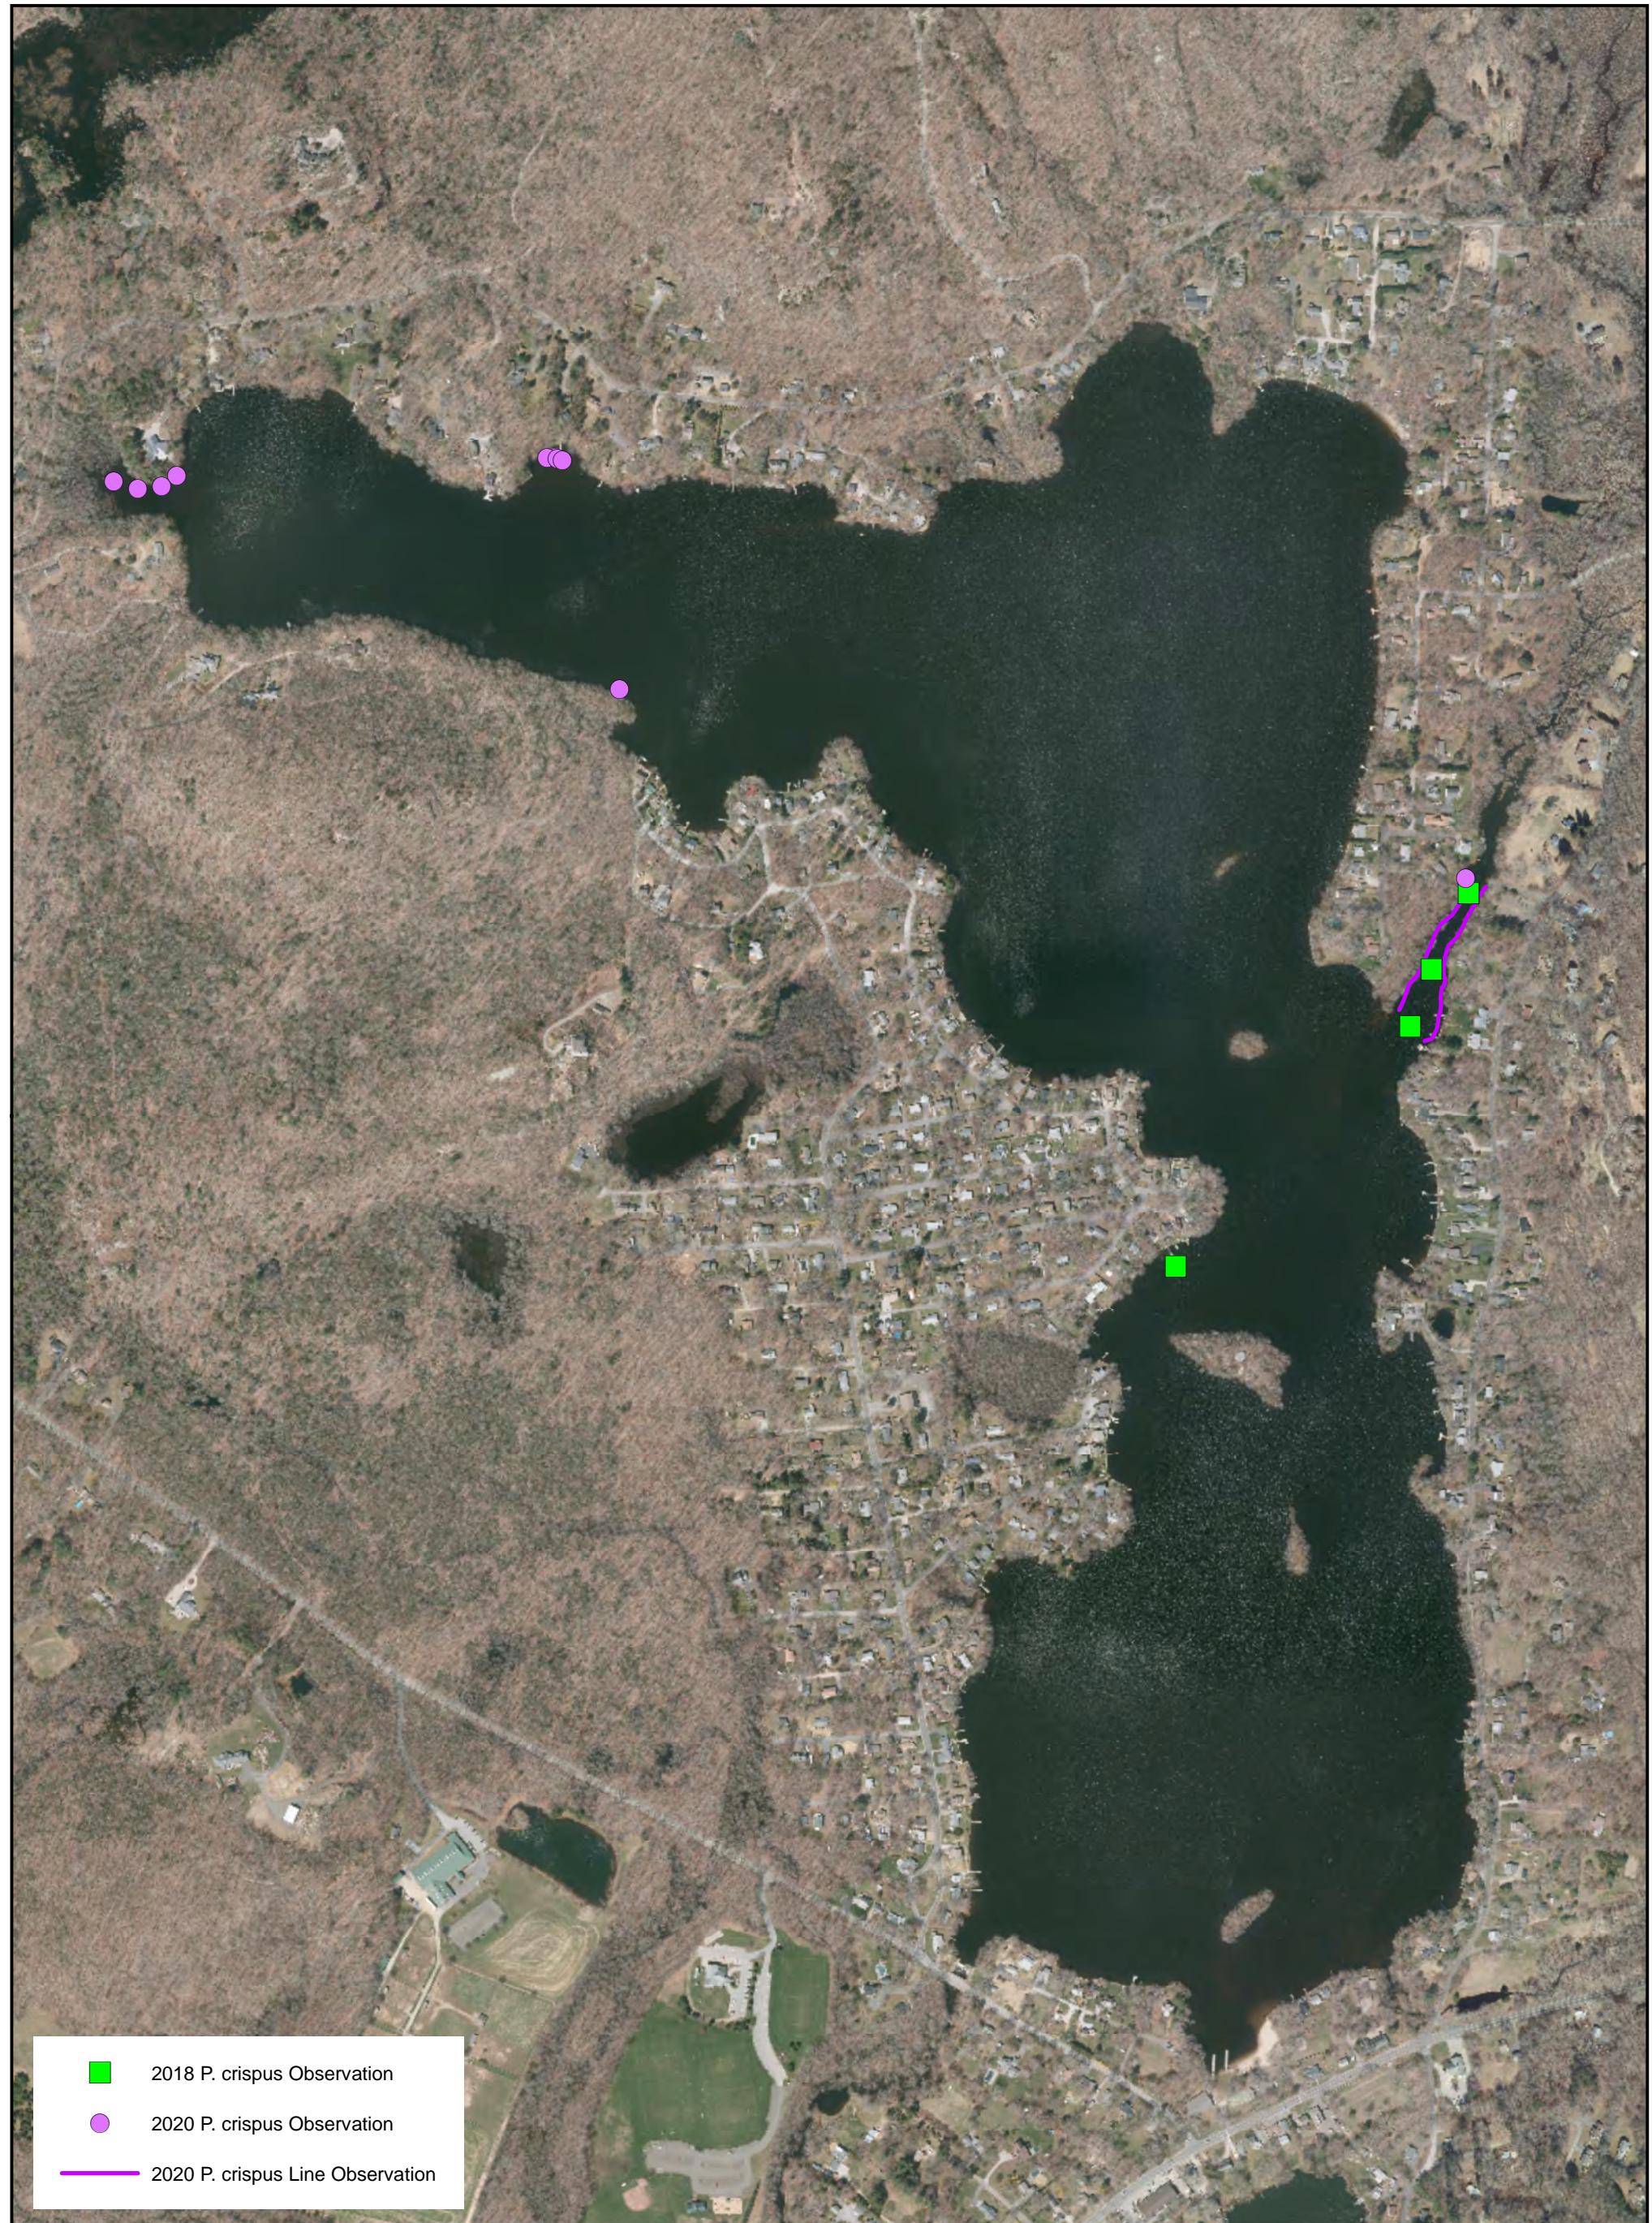
Figure 4
2018-2020
Potamogeton crispus
Observations

Potamogeton crispus (curly-leaf pondweed) was not documented in Rogers Lake prior to June of 2018. The 2018 observations consisted of four small populations, three within the Town Boat Ramp inlet, and one across the lake along the western shore (Figure 4). *P. crispus* was still present within the Town Boat Ramp inlet in 2020, but in a much more scattered nature with only one or two plants occurring together. The largest concentration of *P. crispus* observed in 2020 was located along the north shore where several small scattered patches, and one larger 36 square foot patch were found (Photos 6). A single three-foot diameter patch was observed almost directly across the lake from the concentrated area, and four additional small patches consisting of one to three plants were observed (and pulled) at the northwest end of the lake.

We suspect that the apparent increase in *P. crispus* is due in large part to the increase in survey efforts made in 2020. In 2018, SWCA spent two days surveying during the growing season when *P. crispus* would be most readily apparent, compared to five survey days in 2020. Based on our 2020 observations of this species, it is also likely that *P. crispus* was occurring within larger populations of other species in 2018, making it more difficult to observe (Photo 7).

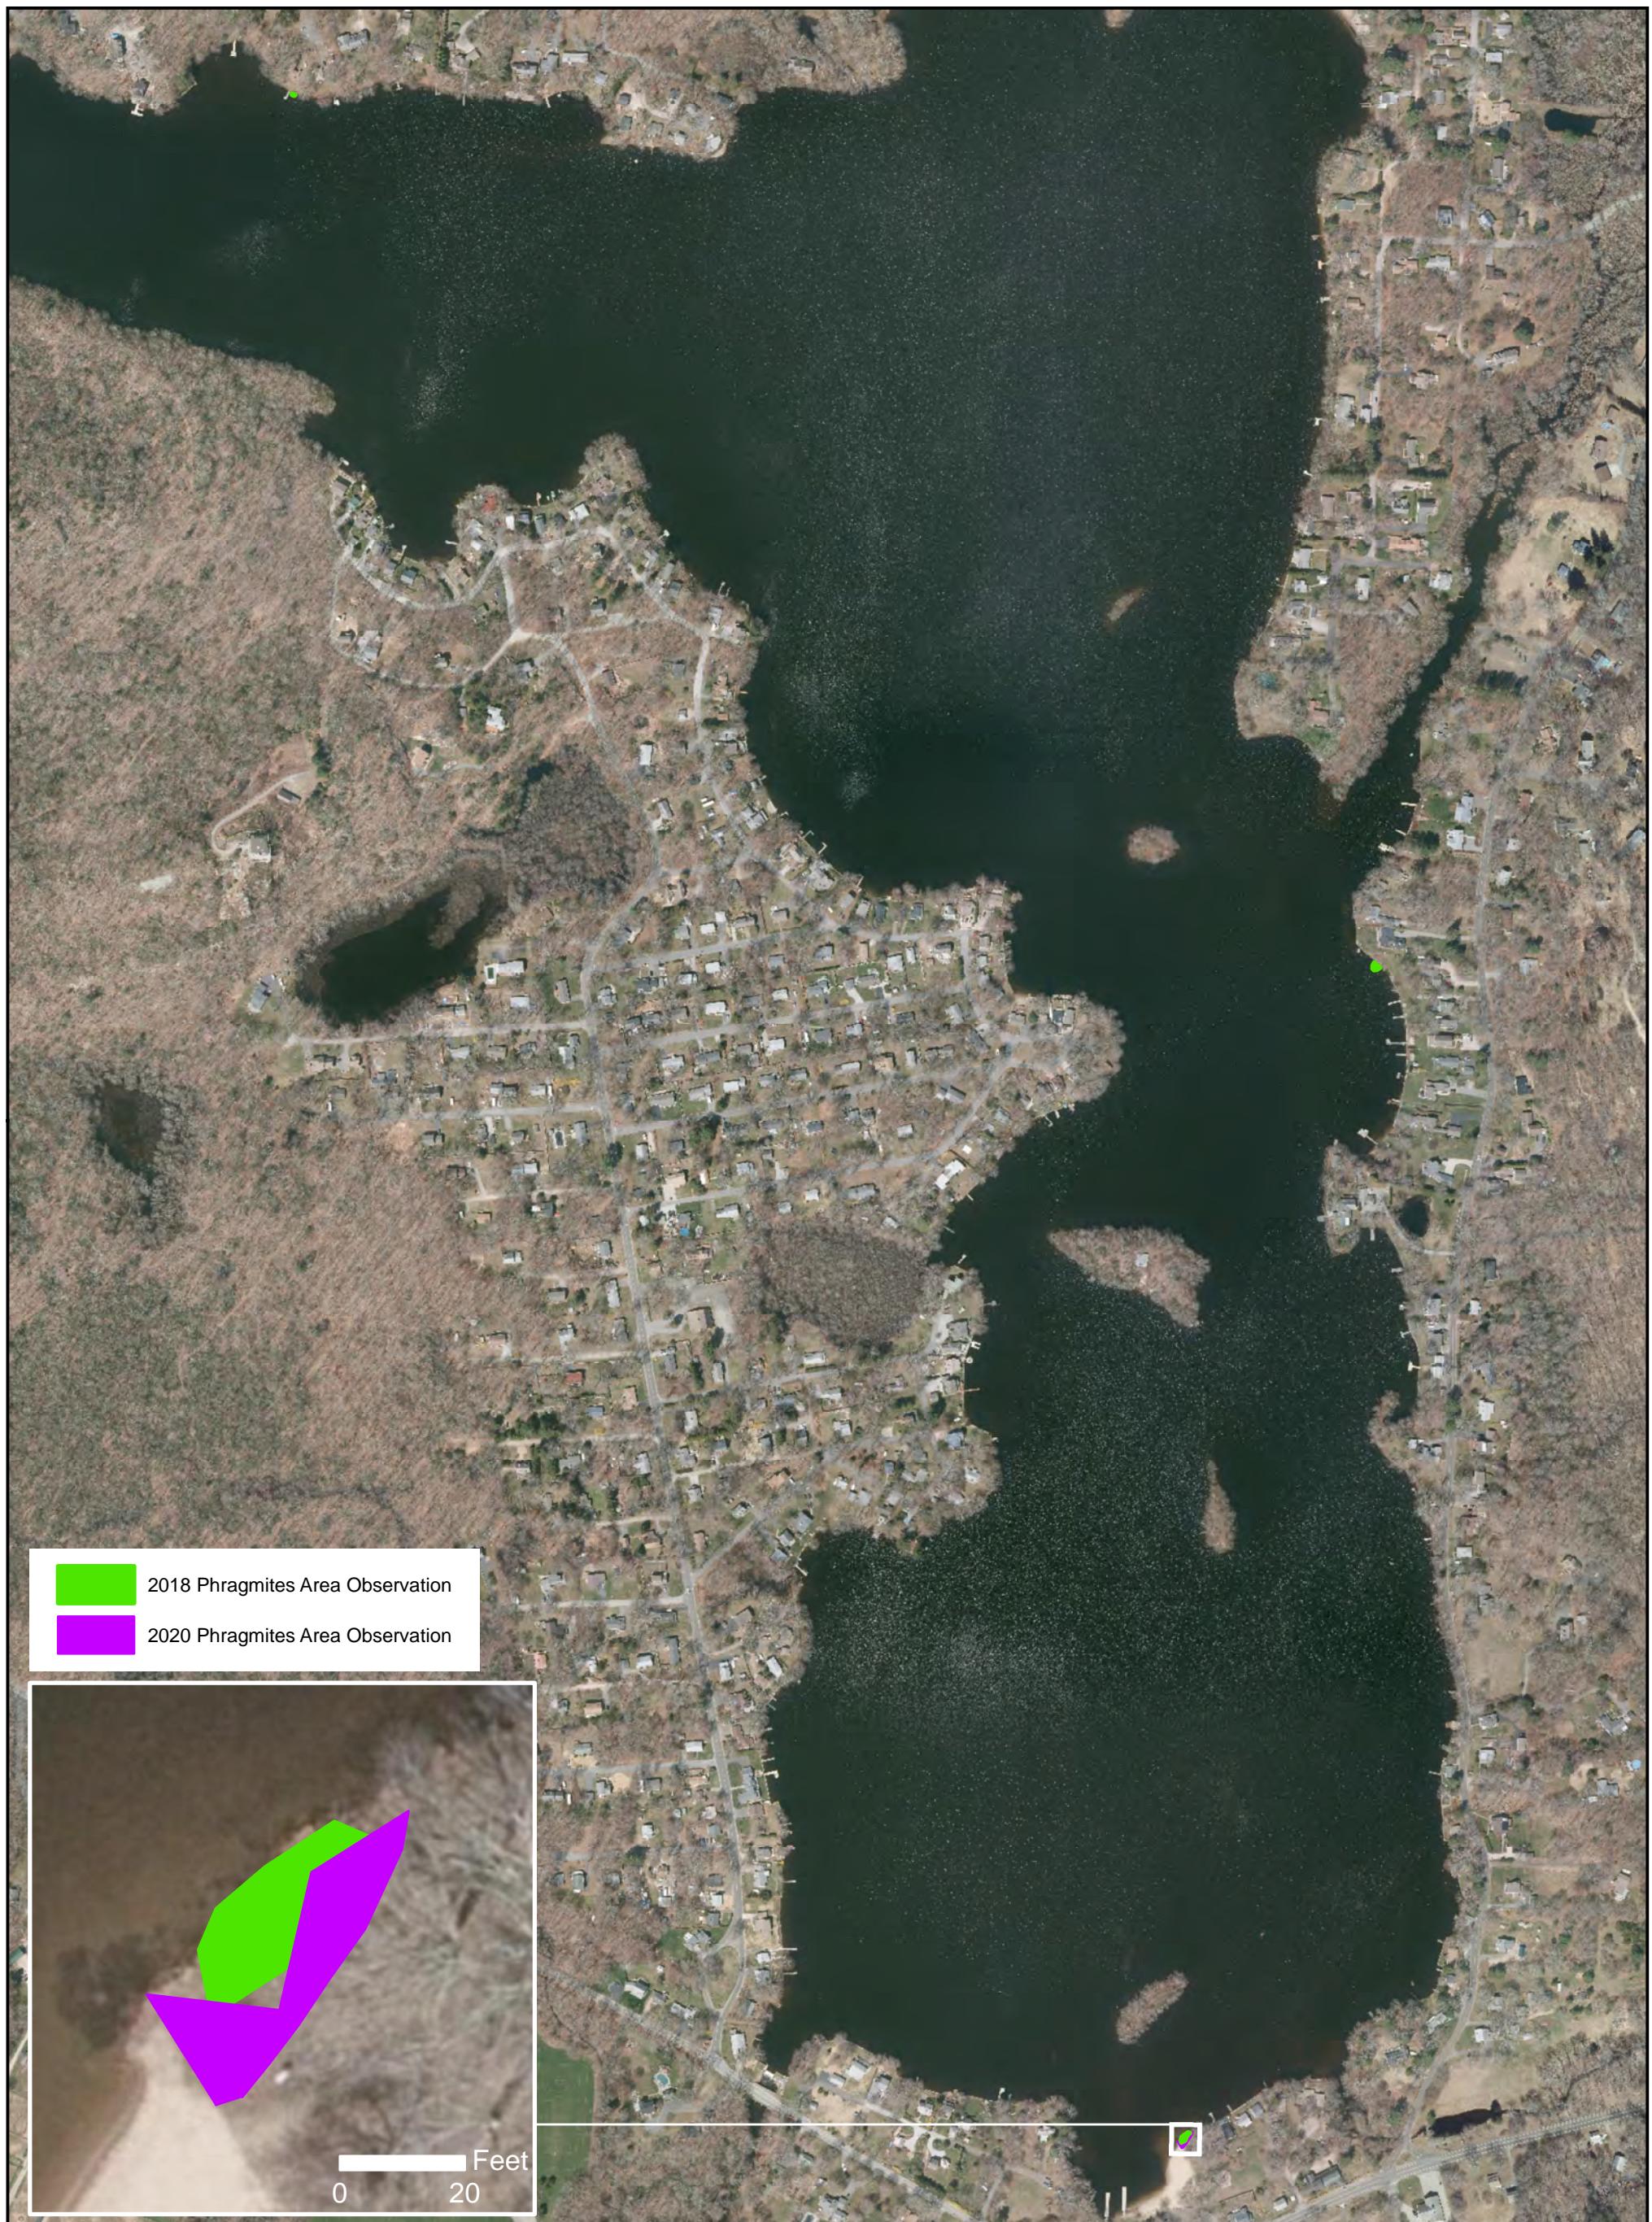
Figure 5
2018-2020 *Phragmites australis* Observations

Phragmites australis (common reed) is not a truly aquatic species and had not been documented on the lake shoreline until the fall of 2018. At that time three small populations were mapped. A small patch along the north shore, and a second patch along the east shore each consisted of only 10 to 20 stems, while the third and larger patch was located at the south end of the lake just east of the beach area. This patch was approximately 325 square feet (30 square meters) in size. The two small patches to the north were not found in 2020, while the size of the larger *Phragmites* patch at the south end of the lake appears to be relatively unchanged (Photo 8). The difference in the apparent shape of this population is likely due to the improved GPS technology used during the 2020 survey.

The fourth invasive species mapped during the 2020 surveys, *Phragmites australis*, was only observed at one of its three previous observed locations. The remaining stand of this reed at the southern end of the lake is still quite small and would likely respond well to herbicide applications.

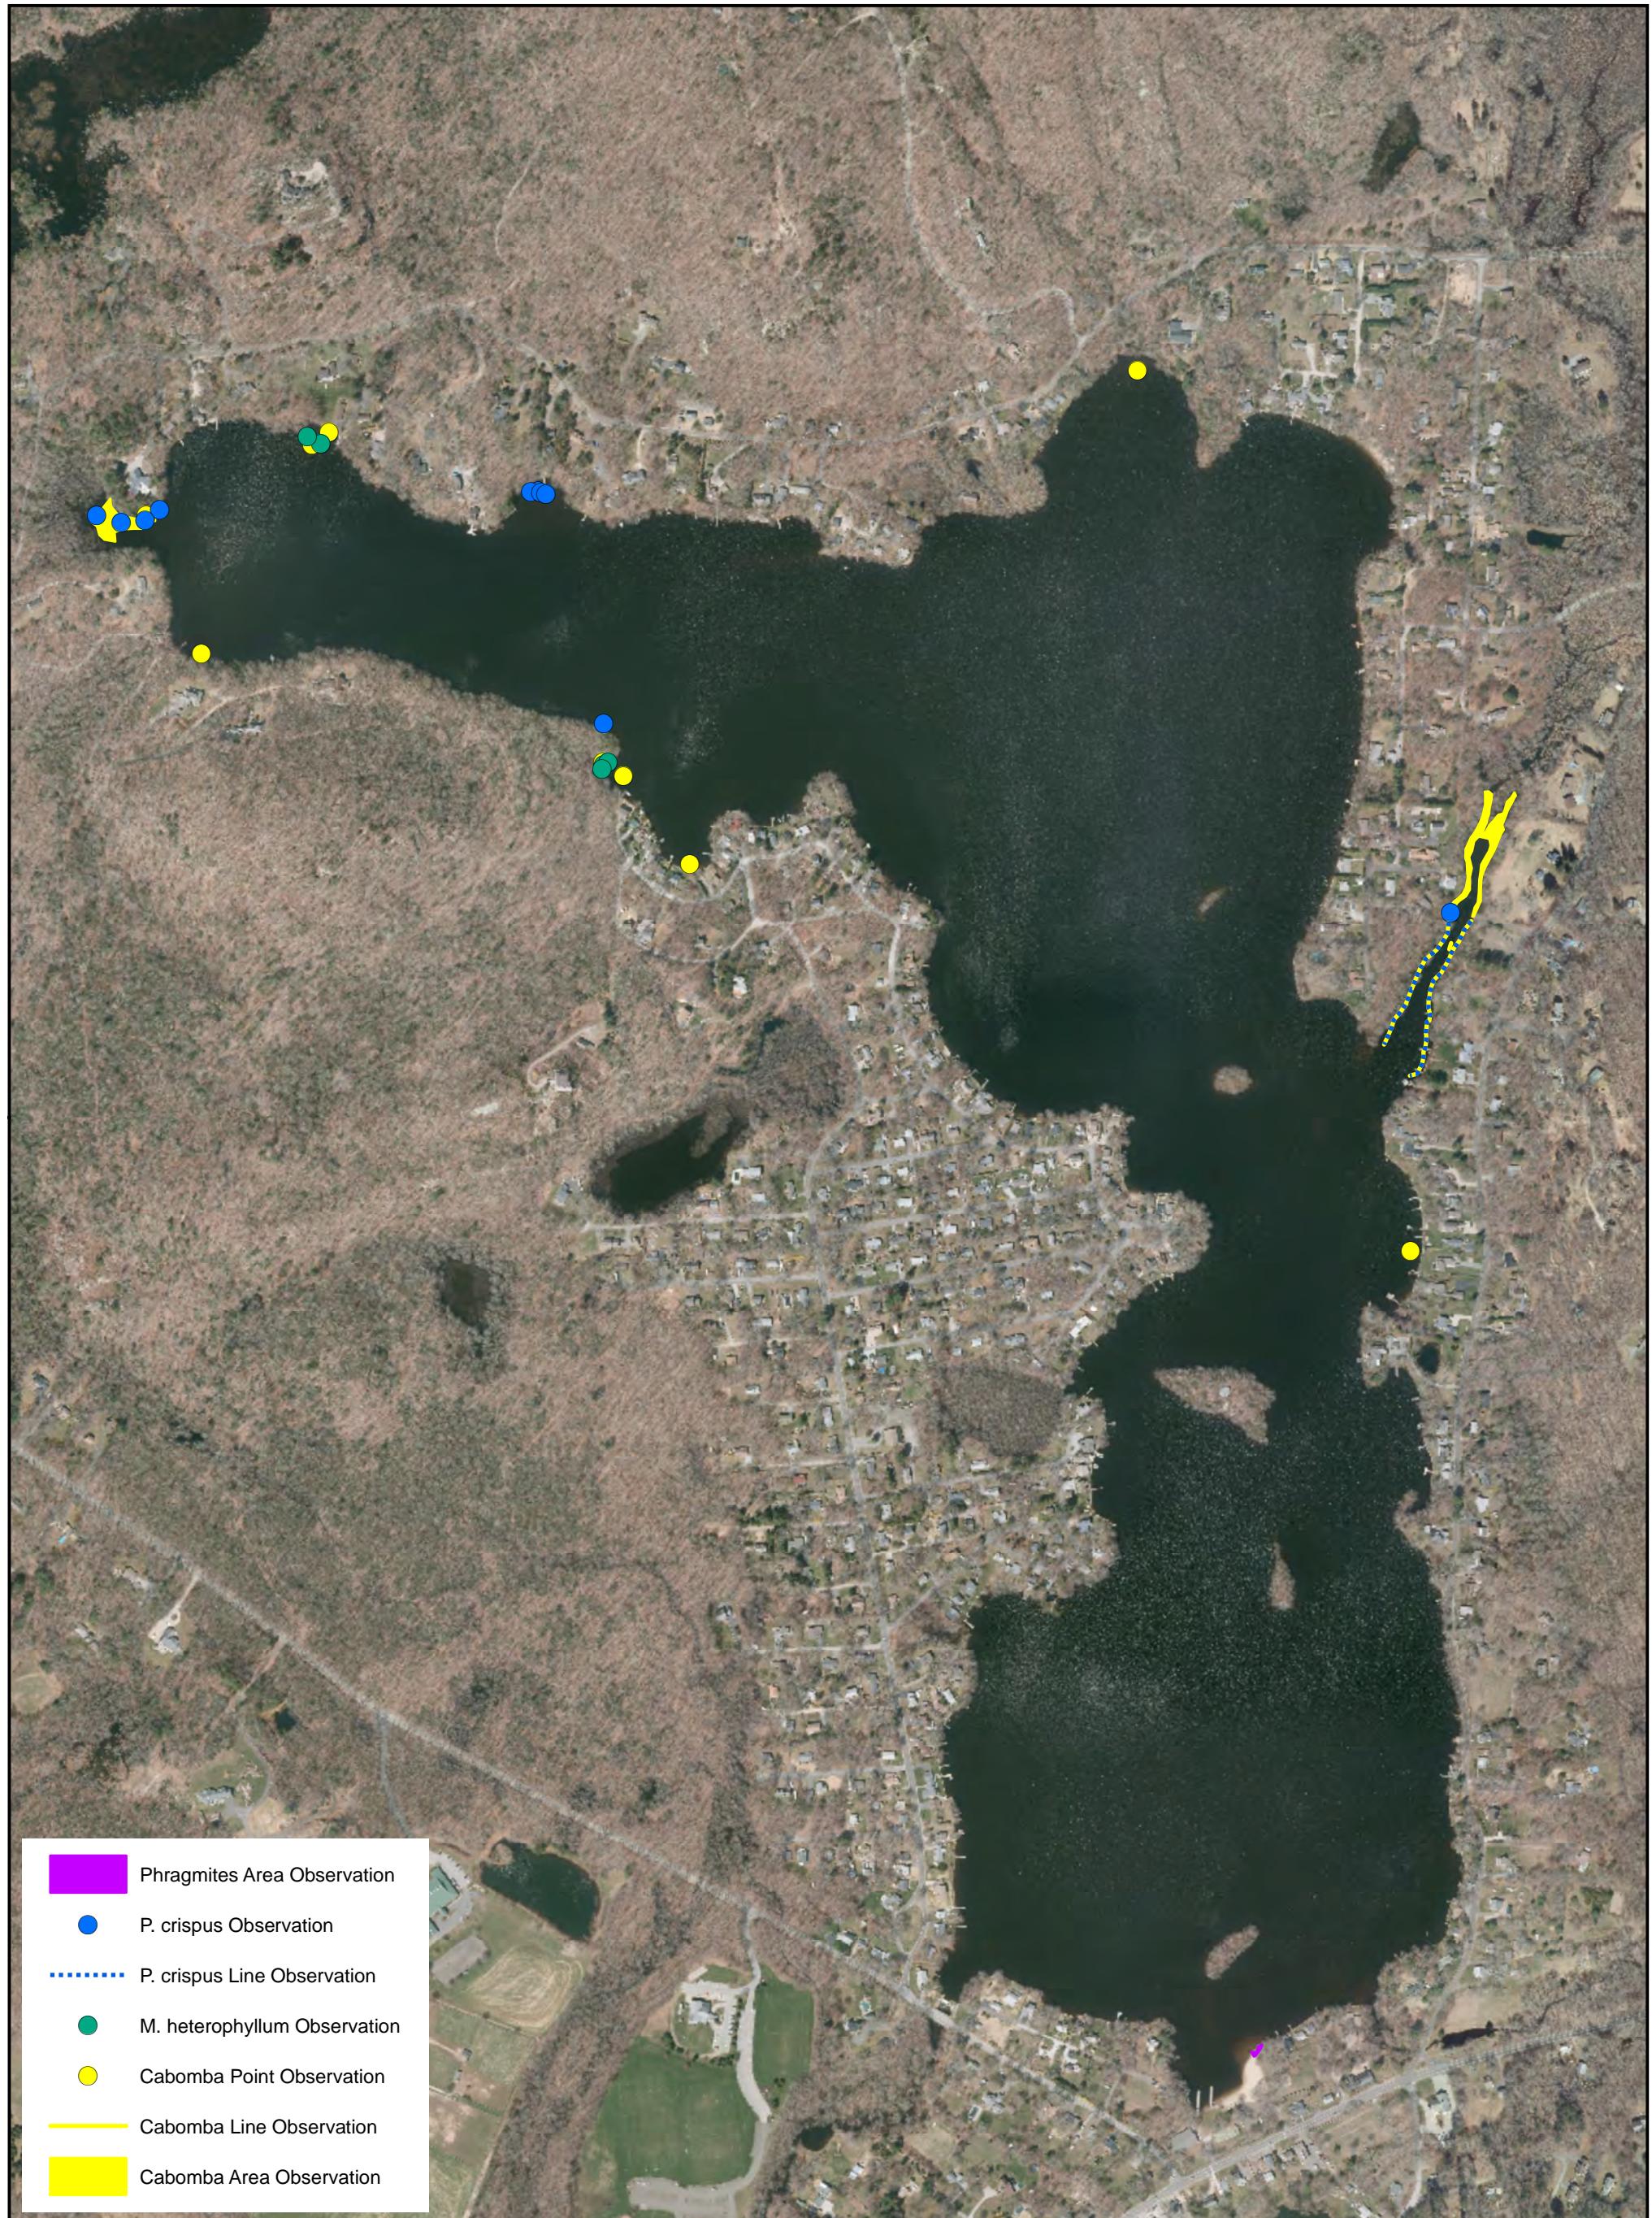
Figure 6
2020
Invasive Species
Observations
Rogers Lake
Lyme & Old Lyme, CT

In June and early July of 2020, SWCA conducted botanical surveys to document and map the distribution of invasive plant species within Rogers Lake in Lyme and Old Lyme, Connecticut (Figure 6). Comparisons between the data collected from this survey effort made with surveys from 2014 and 2018 indicate that the three aquatic invasive species previously identified within the lake, *Cabomba caroliniana*, *Myriophyllum heterophyllum*, and *Potamogeton crispus*, have been greatly reduced through herbicide applications to very manageable levels. The majority of aquatic invasive plant species observed in 2020 occurred in low enough densities and in shallow waters where management through hand-pulling would likely be both feasible and effective.

The only possible exception to this approach would be the two dense patches of *Cabomba* observed in the northwest end of the lake and above the Town Boat Ramp. However, restricted boat traffic in these areas should reduce the *Cabomba* from spreading from these areas to other portions of the lake. Additionally, the *Cabomba* observed at these locations was in relatively shallow waters and could be hand-pulled as well by personnel in kayaks. The larger two populations may require a more long-term effort than invasive aquatic plant species in other parts of the lake; however, hand-pulling may still be the preferred option for reducing *Cabomba* in these areas, rather than an herbicide application.

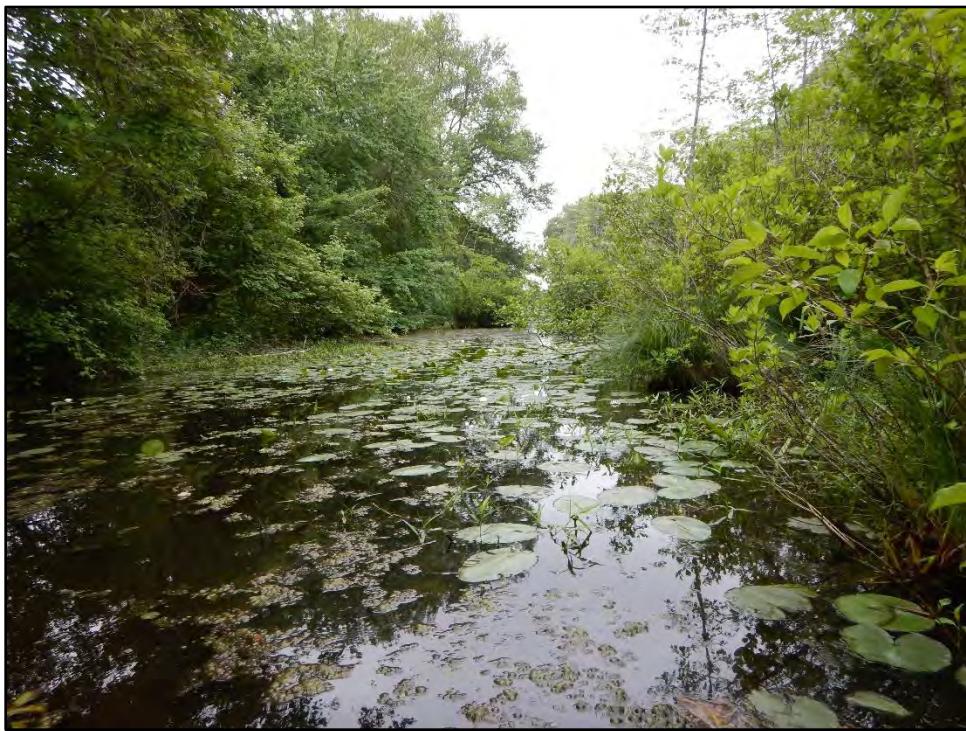
Photo 1. Narrow cove north of Town Boat Ramp where *Cabomba caroliniana* was observed.

Currently there are two areas with relatively dense concentrations of *Cabomba* in the lake. Both occur within inlet-related coves: the first population extends northeast of the Town Boat Ramp located on the east side of the lake. This population was observed in shallow water between six inches and three feet and only reached high densities at the

upstream end of the two inlets (Photos 1 and 2). Downstream of the boat ramp, only scattered plants were observed along both sides of the inlet, continuing out to the mouth of the inlet. The second large population of Cabomba is in the northwest end of the lake, mixed with white water lily (Photos 3 and 4). This population was also entirely within shallow waters between six inches and three feet at the time of the survey.

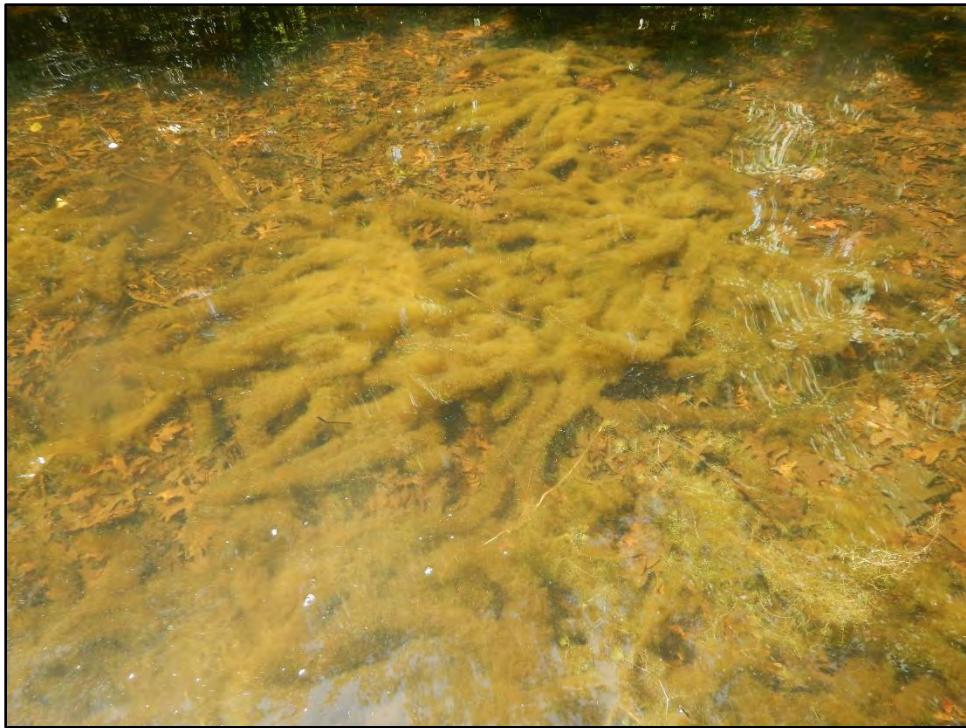
Photo 5. The largest patch of *Myriophyllum heterophyllum* observed in 2020. Note that this patch was located in very shallow water.

Myriophyllum heterophyllum (variable-leaf milfoil) has also diminished significantly since 2014. *M. heterophyllum* is now the least abundant aquatic invasive species observed in the lake (Figure 3). In contrast, it was the most abundant and wide-spread invasive aquatic plant species observed in 2018. In past surveys, *M. heterophyllum* populations characteristically consisted of large, dense patches usually hundreds of square feet in size occurring in numerous locations throughout the lake, with few or no other species mixing in. In 2020, we observed *M. heterophyllum* in only two locations. The first location, along the northwestern shoreline, consisted of two ten square foot patches in about three feet of water, while the second site, located approximately 1,700 feet to the southeast, was approximately 150 square feet in size in up to 1.5 feet of water (Photo 5).

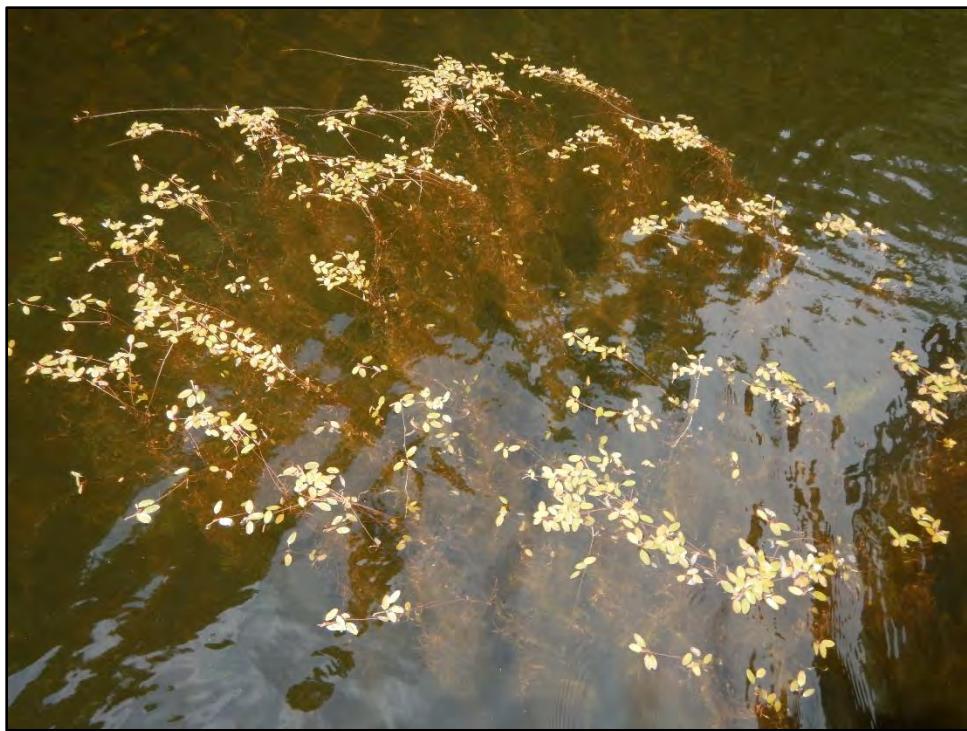
Photo 8. The native *Potamogeton bicupulatus*, observed throughout much Rogers Lake in 2020.

While invasive aquatic plant species were the focus of the 2020 survey, SWCA did make note of some native aquatic plant species observations that are worth mentioning here. Several residents around the lake inquired about a pond weed that they had not noticed prior to this year (Photo 9). SWCA took samples and identified the plant as *Potamogeton bicupulatus*, as well as possibly the very similar *P. spirillus* both native pond weeds that have likely been in the lake for some time, but are now more readily apparent with the reduction in invasive species cover. We also noted the presence of another species of *Potamogeton*, *P. robbinsii*, throughout many areas previously dominated by *M. heterophyllum*. This too is a native species that generally does not grow to the lake surface (Photo 10). We also noted an apparent increase in a native alga species that closely resembles a vascular plant (Photo 11). This alga was located on the lake bottom in several areas that had once been dominated by *M. heterophyllum* and *Cabomba*. SWCA has not yet identified this alga to species.

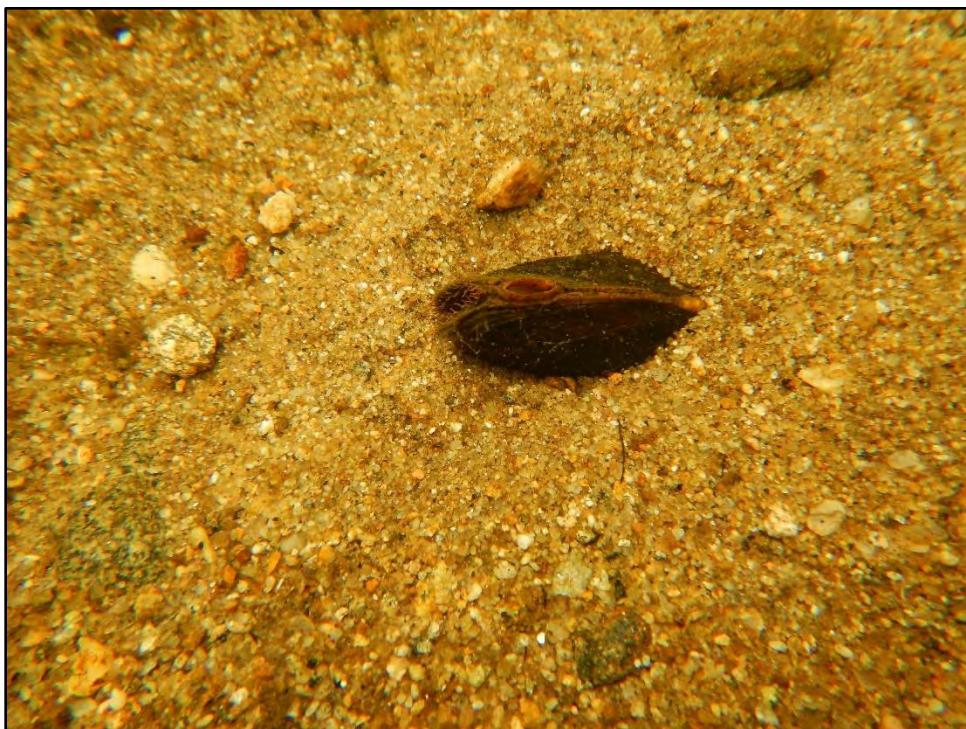
Photo 11. Filtering eastern pondmussel, a species of Special Concern in Connecticut.

SWCA observed four eastern pondmussels (*Ligumia nasuta*), a species of Special Concern in Connecticut. All four mussels were found close to three of the islands surveyed for invasive plants and appeared to be in good condition. We also noted the presence of numerous dense mussel beds of common native freshwater mussels that also appeared to be healthy (Photos 12 and 13).
