Rogers Lake

Old Lyme, CT

**Aquatic Vegetation Survey
Water Chemistry
Aquatic Plant Management Options**

February 10, 2022

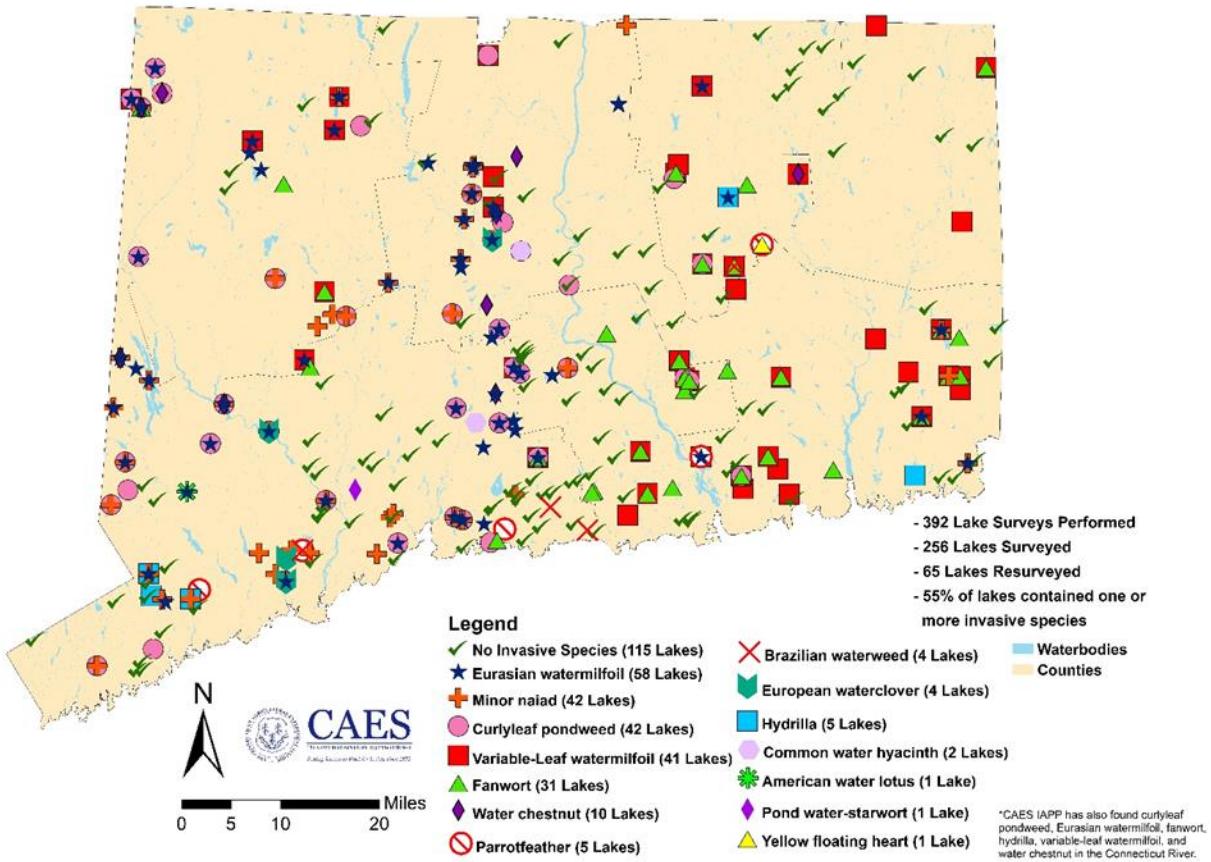
Figure 1. Locations of invasive aquatic plants found by CAES IAPP from 2004 – 2021.

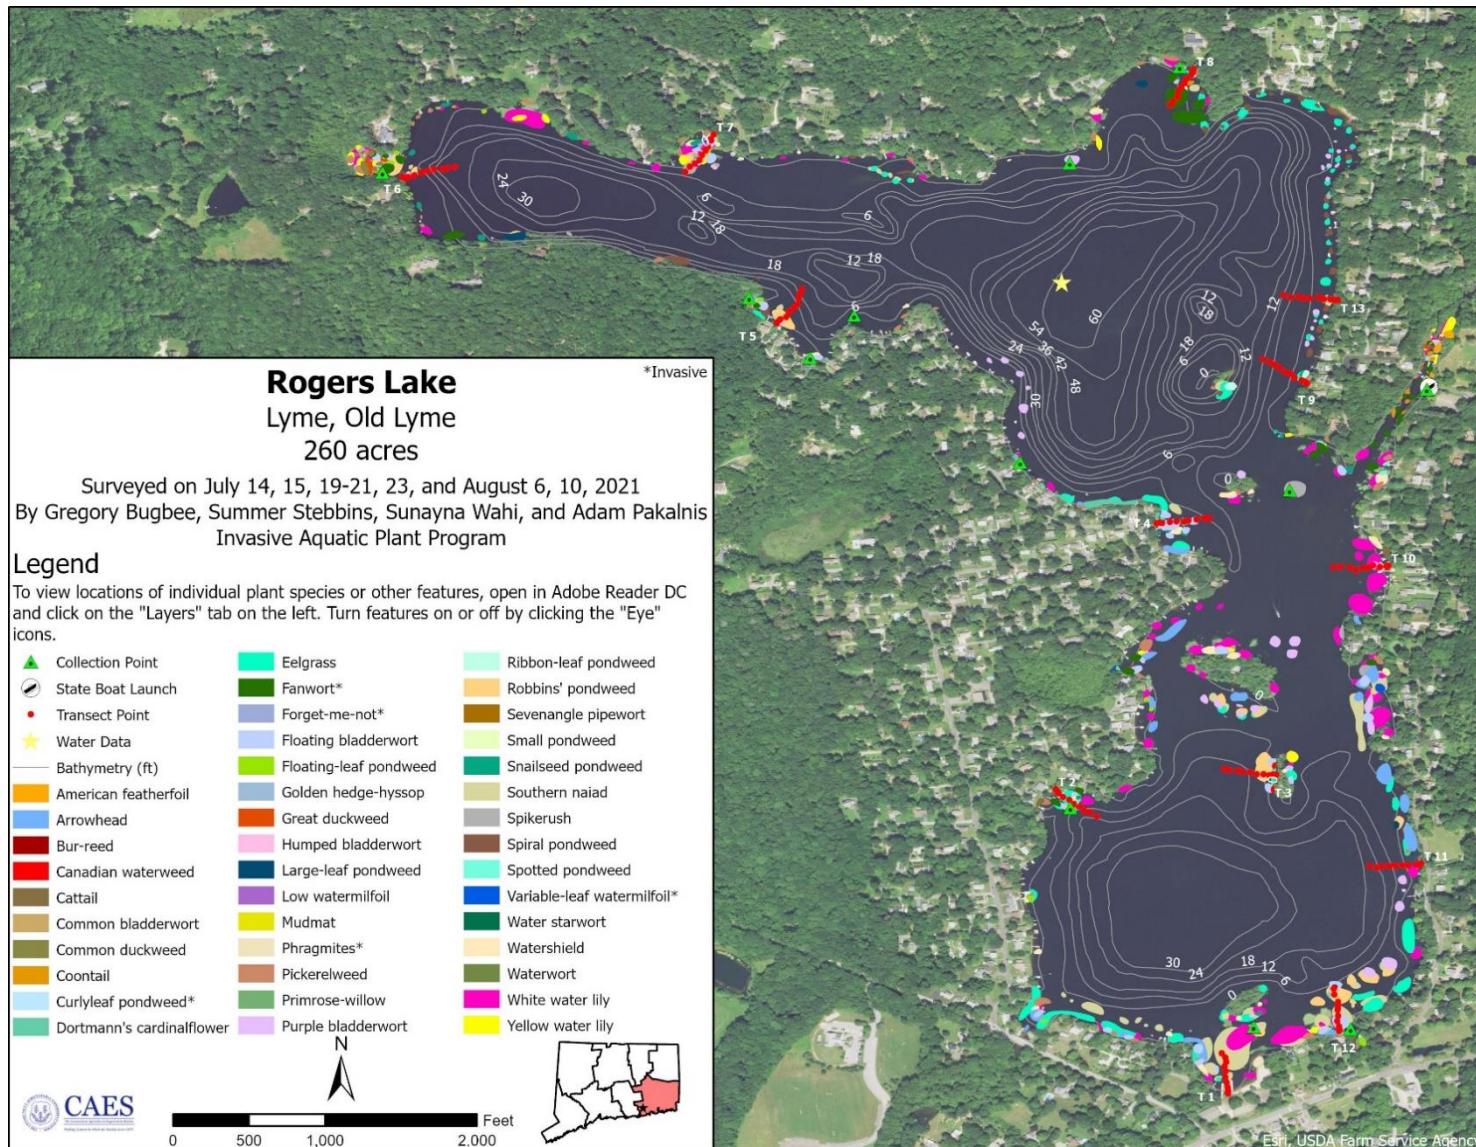
Figure 2. 2021 aquatic plant survey of Rogers Lake

Compared to 2006, Rogers Lake's aquatic vegetation is more sporadic and is less abundant in 2021 (Figures 2 & 3). Navigation was rarely impeded except for a few shallow coves. Vegetation in Rogers Lake was limited to depths of less than 3 m (10 ft.). This is probably the result of herbicide treatments over the last decade. We found three invasive and 32 native plant species in Rogers Lake in 2021 compared to 30 native and one invasive species in 2006 (Table 1). Rogers Lake contains among the greatest number of plant species found in any waterbody surveyed by CAES IAPP (2022). Fanwort, variable-leaf watermilfoil, and curlyleaf pondweed were the invasive species present in 2021 while only variable-leaf watermilfoil occurred in 2006 (see appendix for descriptions). Fanwort was the most common invasive species and was found in the northern section of the lake by Transect 8 and Transect 7, in the cove by the state boat launch, and sporadically along the shore-

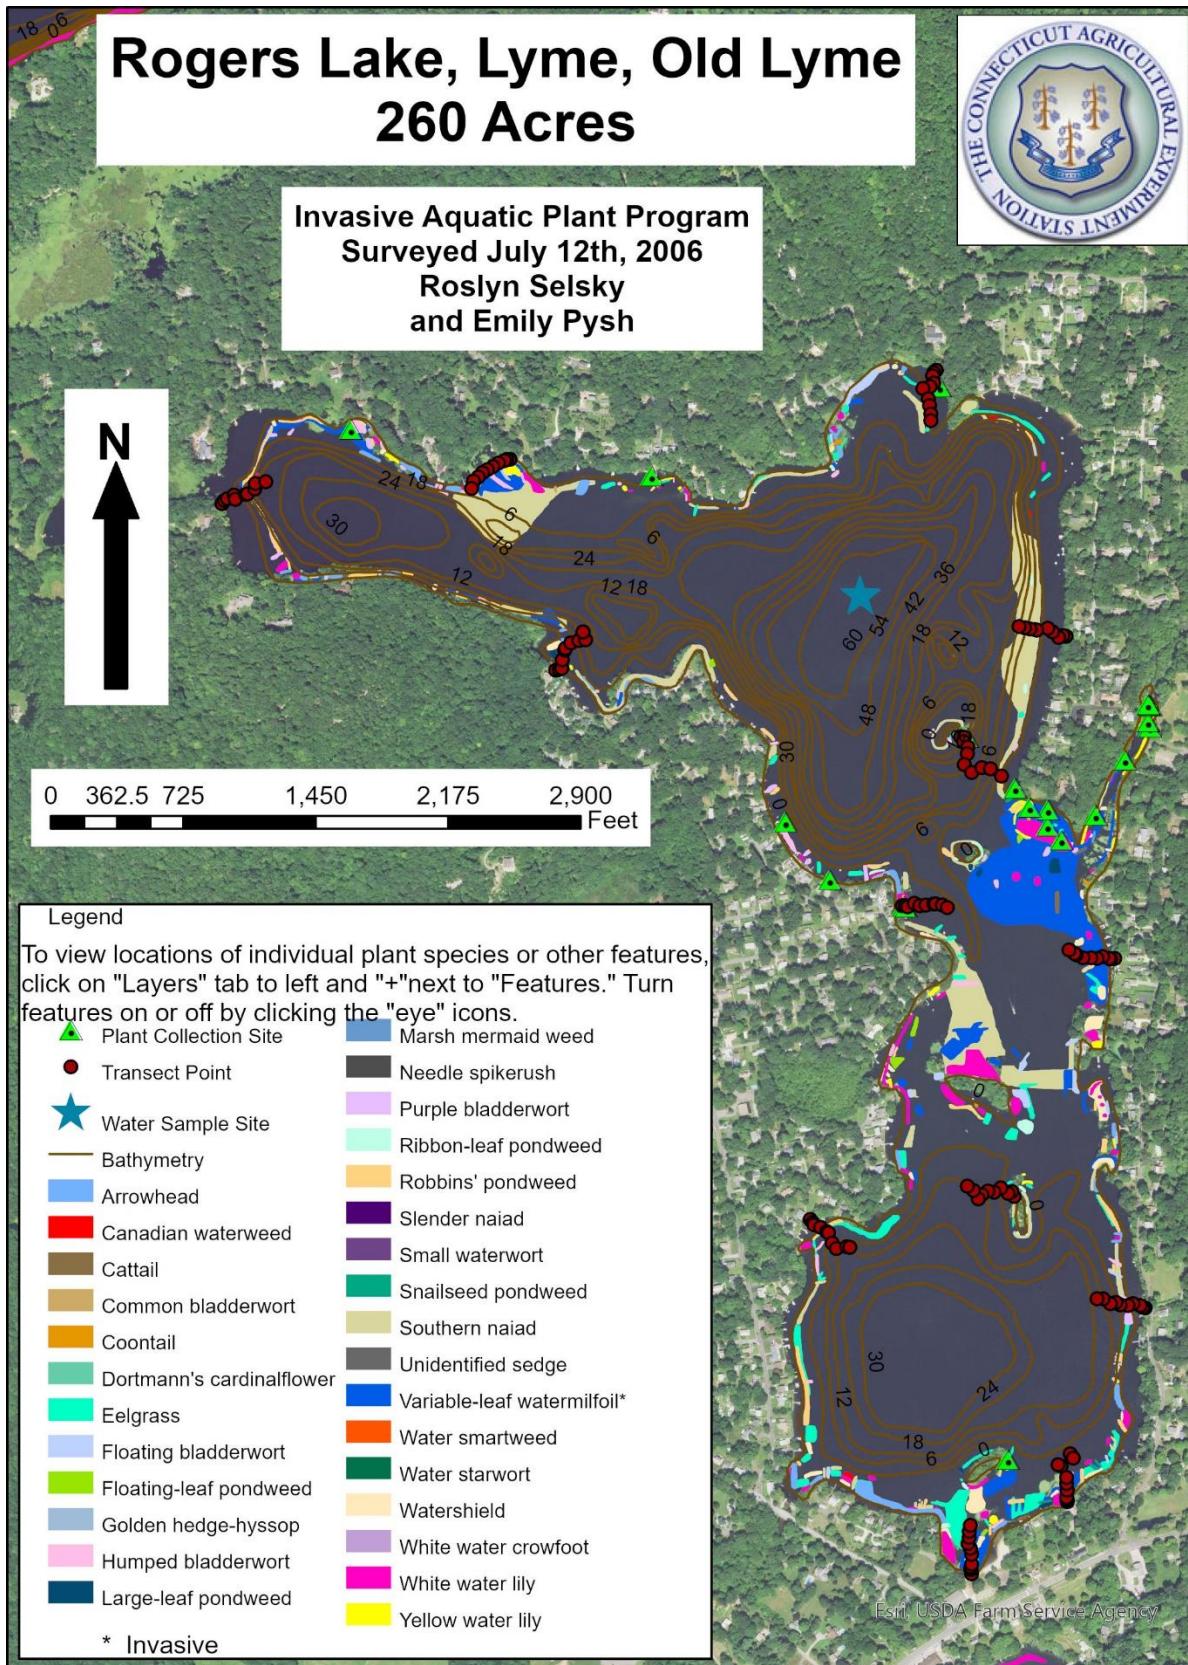
Figure 3. 2006 aquatic plant survey of Rogers Lake

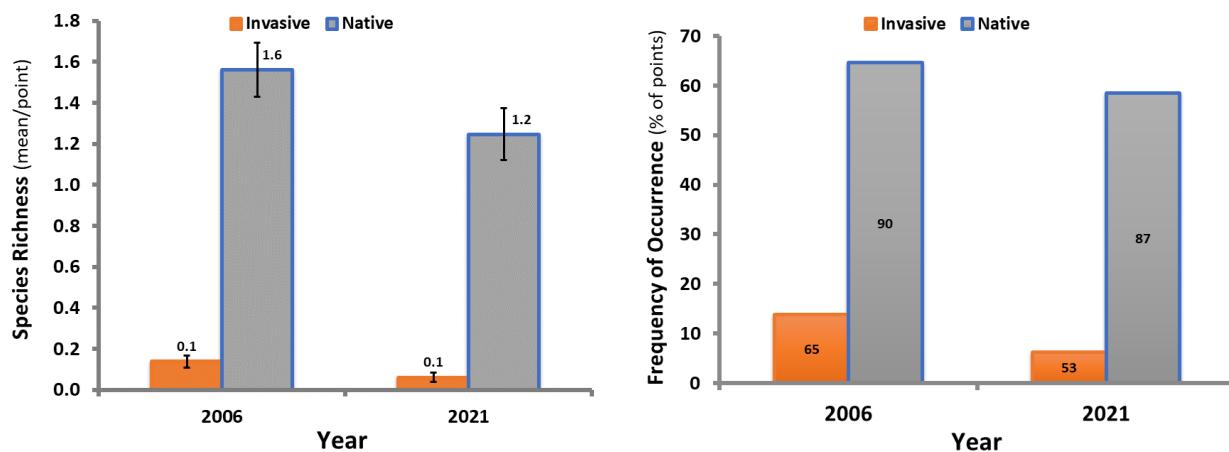
Figure 4. Species richness (left) and frequency of occurrence (right) of aquatic plants in Rogers Lake on transects in 2006 and 2021.

Native aquatic plant species richness (number of species) per transect point decreased slightly from 1.6 in 2006 to 1.2 in 2021 while invasive species richness held constant at 0.1 (Figure 4, left). The similarities in invasive species richness between years is likely because off the herbicide management program that controlled fanwort and curlyleaf pondweed which appeared after our 2006 survey. The slight decrease in native species richness on transects may be due to the herbicide treatments, but because they are minor, there are likely no negative effects on the native plant community.

Comparisons of the frequency of occurrence (FOQ) of native and invasive plants on transect points found a slight decrease in total native species and total invasive species from 2006 to 2021 (Figure 4, right, see appendix for transect data). The most frequently found native plants in 2021 were southern naiad (21%), floating bladderwort (21%), and Robbins’ pondweed (17%) (Table 1). Variable-leaf watermillet FOQ decreased substantially on transects from 14% in 2006 to 2% in 2021 while fanwort increased from 0% in 2006 to 4% in 2021.

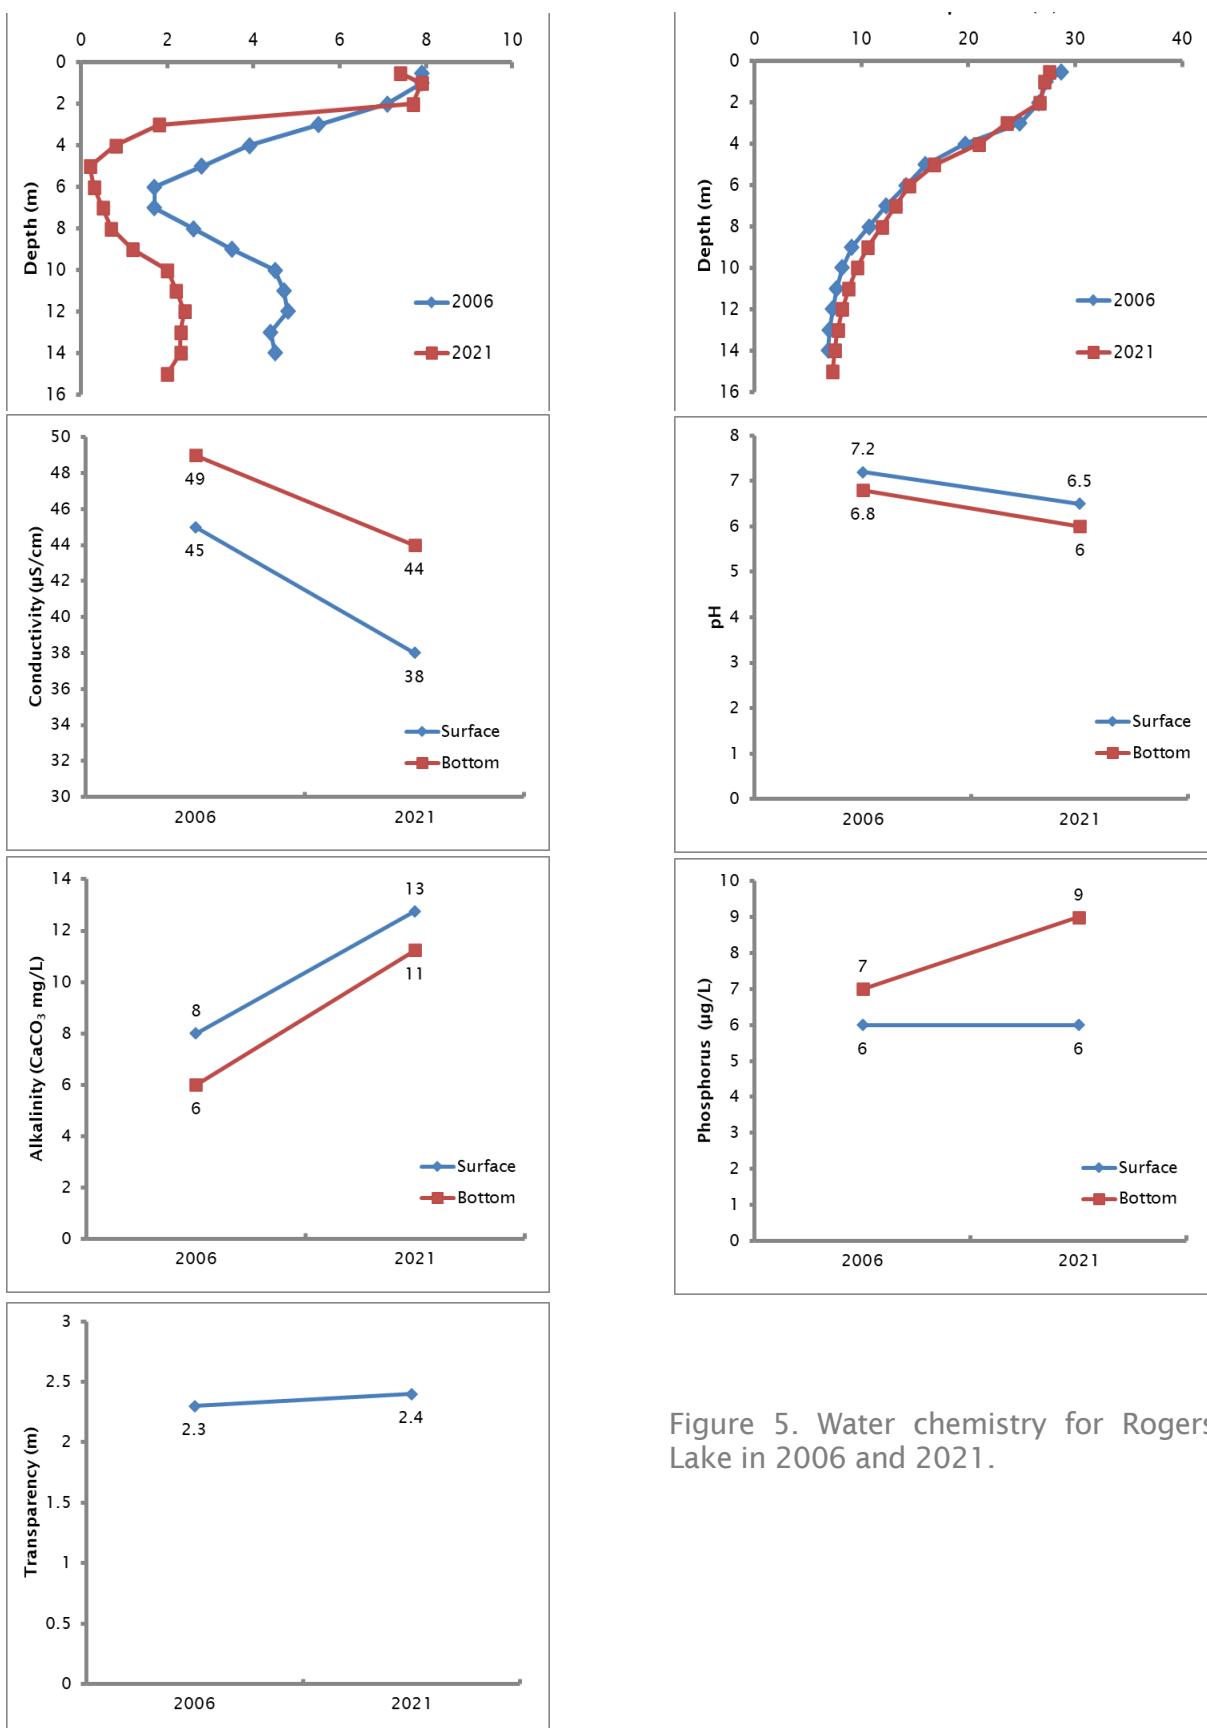
Figure 5. Water chemistry for Rogers Lake in 2006 and 2021.

Water clarity in Connecticut's lakes ranged from 0.3 - 10 m (1 - 33 ft) with an average of 2.3 m (8 ft) (CAES IAPP 2022). Rogers Lake had a water clarity of 2.4 m (8 ft) in 2021 compared to 2.3 m (7.5 ft) in 2006 (Figure 5). In 2021, water clarity was limited by the tea color produced by naturally occurring organic extracts. Rogers Lake is a relatively deep Connecticut lake; this results in significant summertime stratification of temperature and dissolved oxygen (Figure 5). Dissolved oxygen concentrations in 2006 and 2021 were high near the surface, declined to near zero between 4 - 8 m (13 - 21 ft) and then increased slightly. Our equipment was unable to reach the bottom of the lake, but it is likely that dissolved oxygen returned to near zero at the bottom. This anoxic zone does not support fish but is typical in most CT lakes. The temperature profile between 2021 and 2006 were remarkably similar with temperatures near 28° C (82° F) to a depth of about 2 m (7 ft) and a thermocline from 2 - 12 m (7 - 40 ft) where the temperature gradually dropped to near 8°C (46°F). Deeper water exhibited little further temperature change. The pH was near neutral (6.0 - 7.2) and only decreased slightly from 2006. The alkalinity of 6 - 13 mg/L CaCO₃ is low for Connecticut lakes which range from near 0 to >170 (CAES IAPP, 2022). Low alkalinity waterbodies are more prone to pH change due to outside influences such as watershed activities and acid rain. Conductivity is an indicator of dissolved ions that come from natural and man-made sources (mineral weathering, organic matter decomposition, fertilizers, septic systems, road salts, etc.). Connecticut waterbodies typically have conductivities that range from 50 -250 µS/cm. Rogers Lake's conductivity in 2021 was 44 µS/cm at the surface and 38 µS/cm at the bottom which is slightly lower than the 49 µS/cm at the surface and 44 µS/cm at the bottom observed in 2006. These values place Rogers Lake as having among the lowest conductivities in Connecticut.

A key parameter used to categorize a lake's trophic state is the concentration of phosphorus (P) in the water column. High levels of P can lead to nuisance or toxic algal blooms (Frink and Norvell 1984, Wetzel 2001). Rooted macrophytes are less dependent on P from the water column as they obtain a majority of their nutrients from the sediment (Bristow and Whitcombe 1971). Lakes with P levels from 0 - 10 µg/L are considered nutrient-poor or oligotrophic. When P concentrations reach 15 - 25 µg/L, lakes are classified as moderately fertile or mesotrophic and when P reaches 30 - 50 µg/L they are considered fertile or eutrophic (Frink and Norvell 1984). Lakes with P concentrations >50 µg/L are categorized as extremely fertile or hyper-eutrophic. Rogers Lake's P concentration in 2021 was 6 µg/L at surface and 9 µg/L near the bottom, which classifies the lake as oligotrophic (Figure 5). Oligotrophic lakes are rare in CT and further testing is needed to confirm this. We tested total nitrogen (TN) for the first time in 2021 and found 540 µg/L the surface and 697 µg/L near the bottom. Although nitrogen is likely less limiting to the growth of aquatic plants and algae compared to terrestrial plants, it may play a role in lake productivity. Frink and Norvell (1984) found TN in Connecticut lakes ranged from 193 - 1830 µg/L and averaged 554 µg/L placing Rogers Lake in the middle.

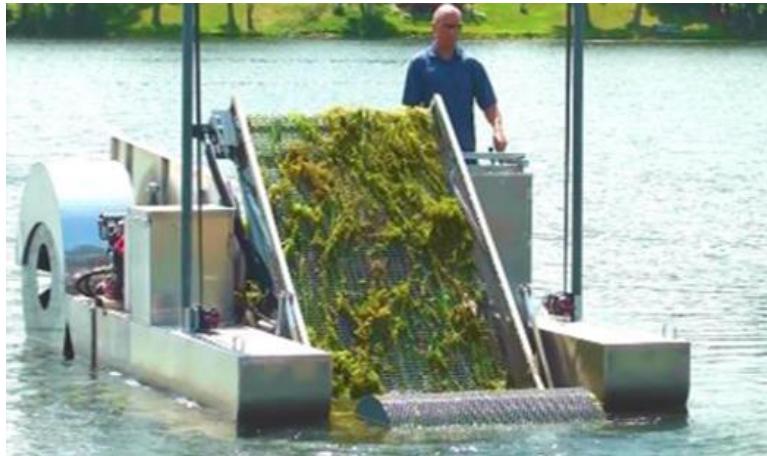
Figure 6. Eco-Harvester removing aquatic plants. Photo Credit: Givens Shorescapes

Mechanical harvesting could be a viable option; however, knowledge of the pros and cons is recommended prior to making large purchases of the necessary machinery. Major benefits of mechanical harvesting include quick results, the ability to target areas and avoid damage to species needing protection, avoidance of aquatic herbicides, and removal of nutrients contained in the harvested vegetation. Drawbacks include the initial expense of the harvesting machine, maintenance costs, rapid regrowth, the need for follow-up work, and costs for vegetation removal and disposal. New mechanical harvesting machines are now available that offer promise for better removal root systems, but this will vary by plant species and sediment type (Figure 6). Reports from users in Connecticut are lacking and therefore the pros and cons of the new technology needs further investigation.

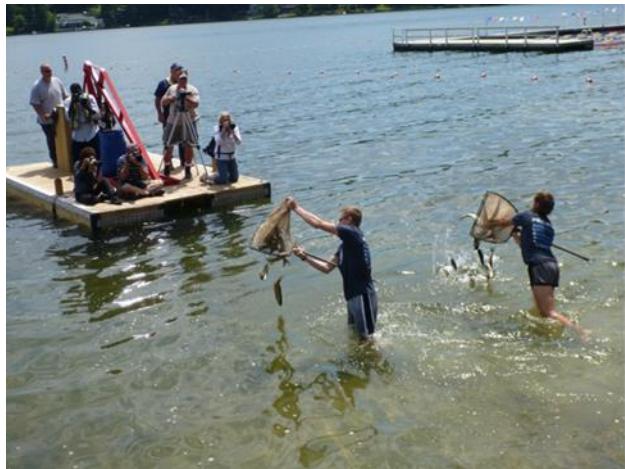
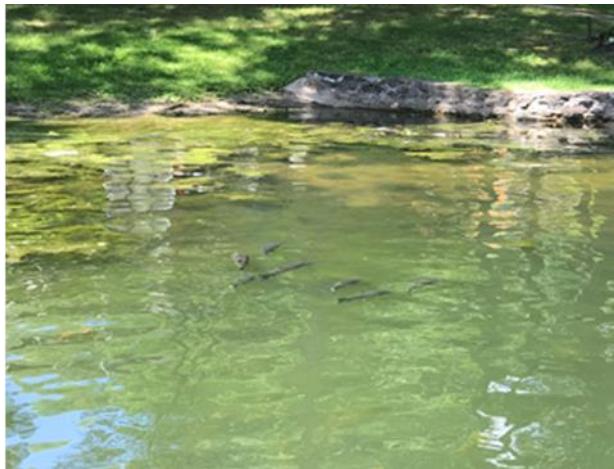
Figure 7. Grass carp introduction into Candlewood Lake in 2015 (left). By 2018 the fish had shown considerable growth (right).

Although efforts are underway to find biological controls for nuisance aquatic vegetation, breakthroughs have been limited. To date the only biological control used in Connecticut is grass carp (*Ctenopharyngodon idella*, Figure 7). Grass carp are herbivorous fish that feed on most submersed aquatic plants. The introduction of grass carp into Connecticut lakes requires approval by CT DEEP. In Connecticut, only sterile (triploid) grass carp are permitted. Introducing grass carp Rogers Lake

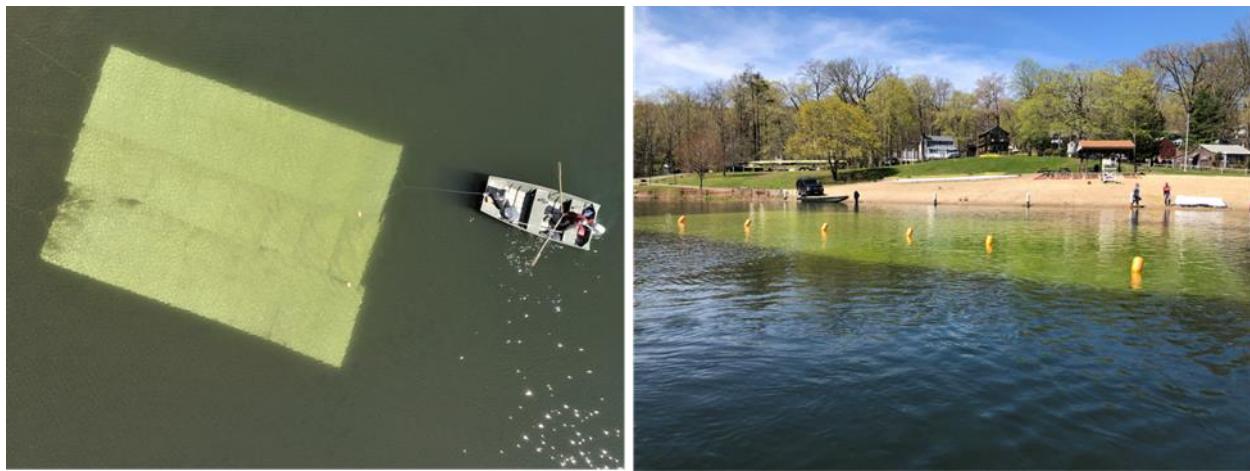
Figure 8. CAES IAPP testing of short-term benthic barriers in Lake Beseck.

Benthic barriers or “bottom blankets” are effective at eliminating nuisance vegetation in small areas such as swim zones, around docks, and pioneer infestations. CAES IAPP has tested short-term placement (<30 days) of the barriers in Lake Quonipaug, Bashan Lake, and Lake Beseck (Figure 8). Season-long control for Eurasian watermilfoil (*Myriophyllum spicatum*) and fanwort was achieved. Although labor intensive, benthic barriers may be able to be moved from place to place during a season for effective control. They can also be used over multiple years, reducing cost of materials.

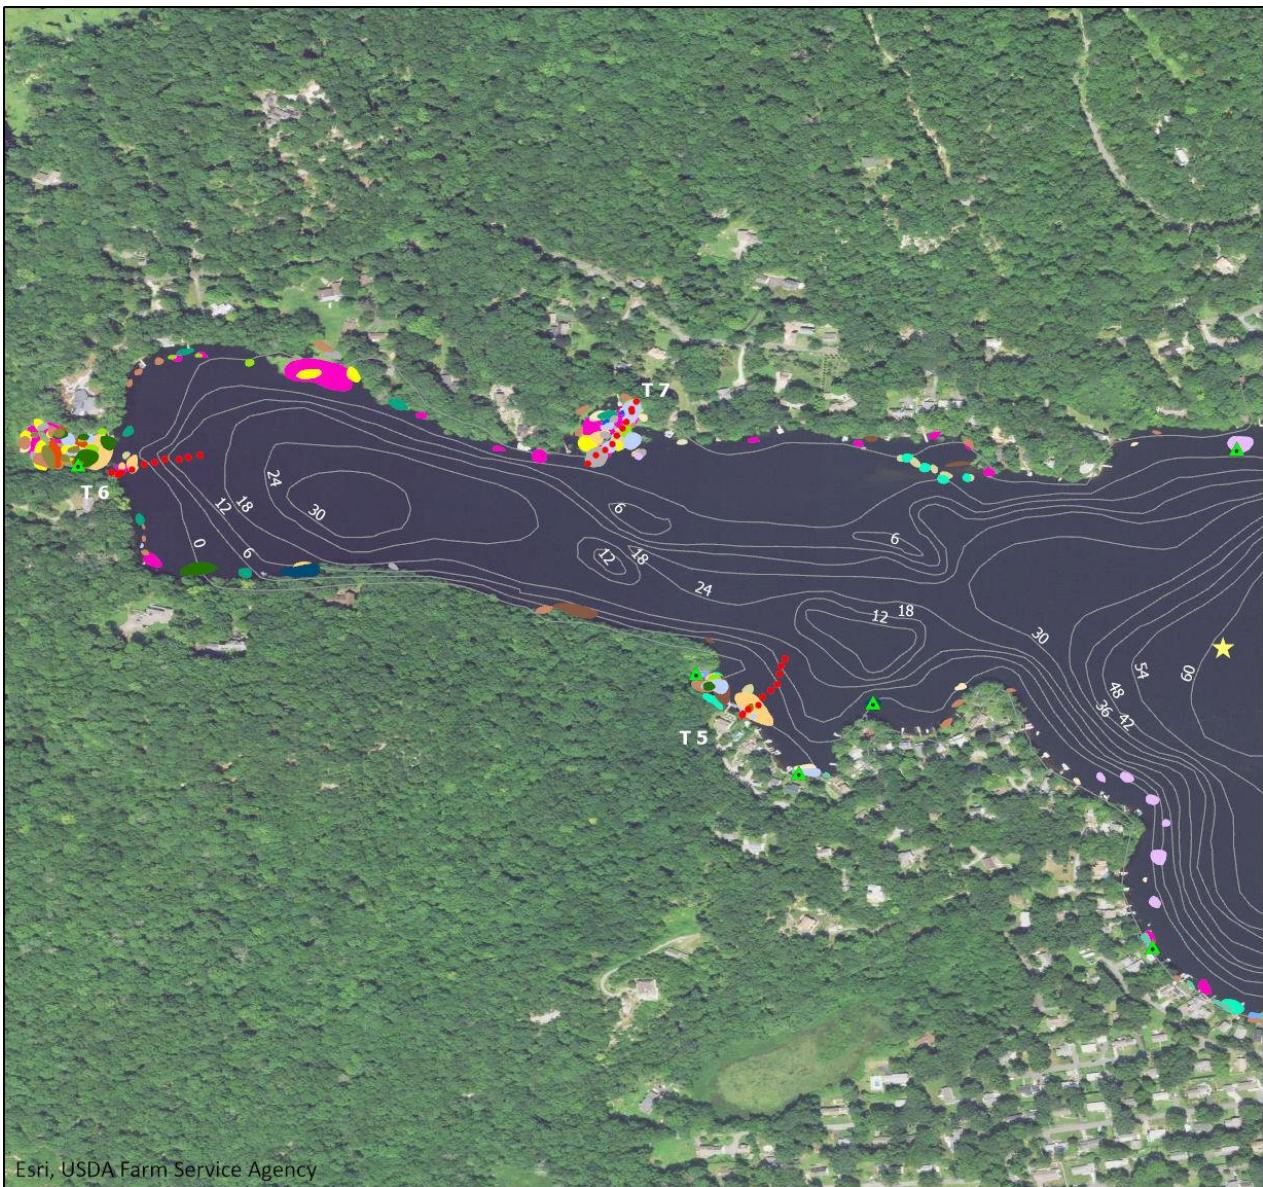
Map 1 of 3

Surveyed on July 14, 15, 19-21, 23,
and August 6, 10, 2021

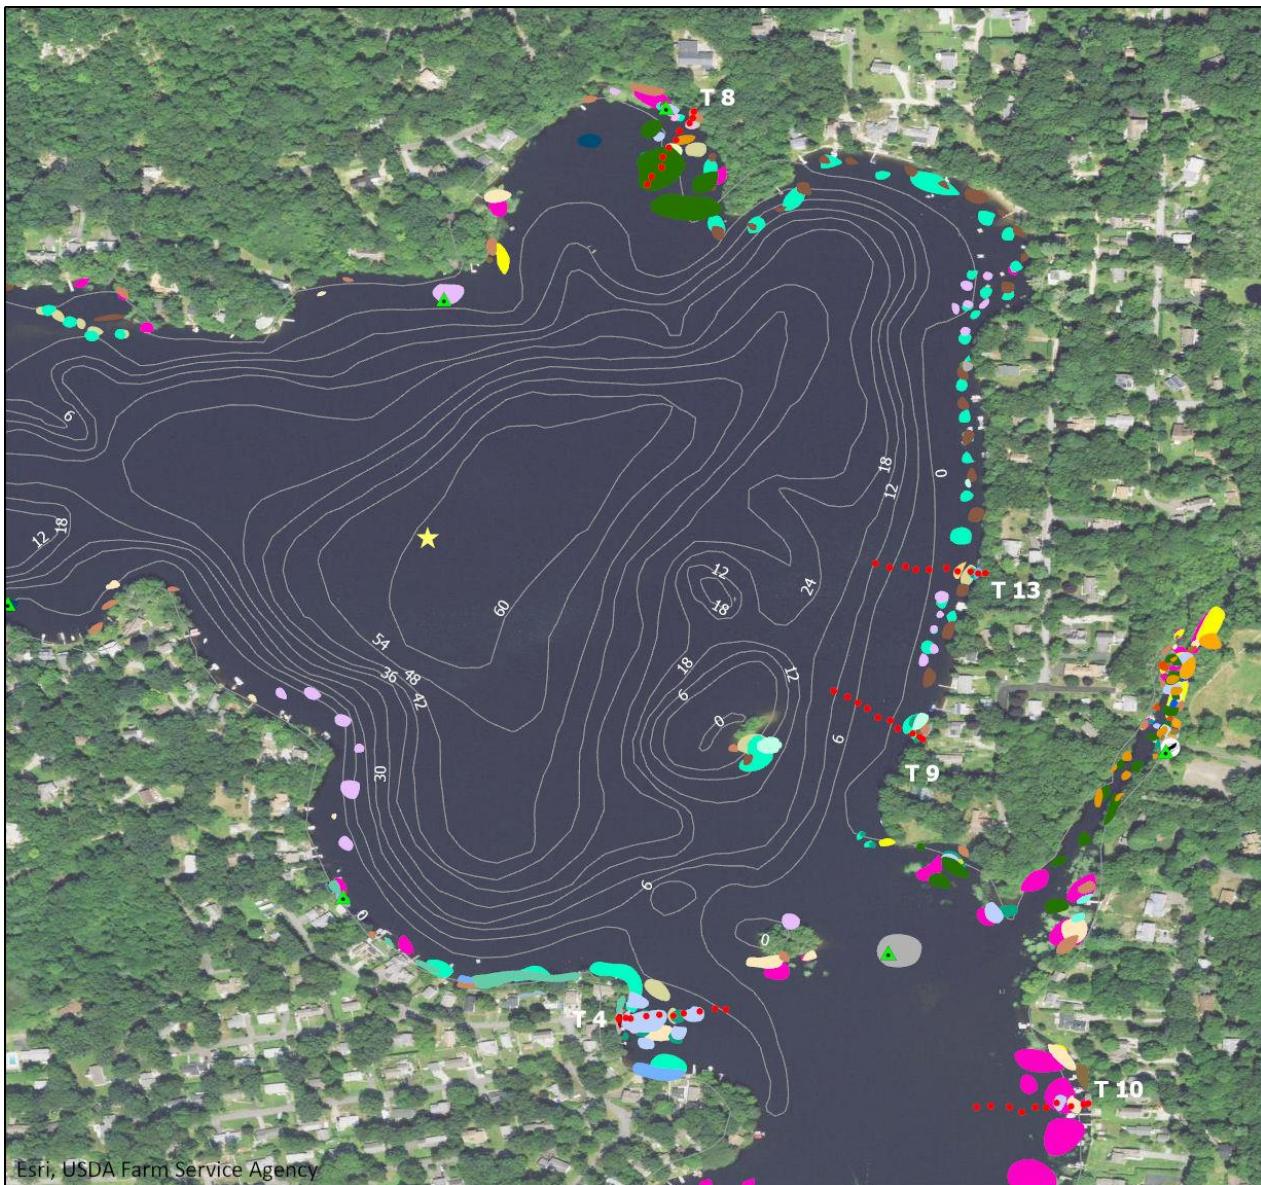
Map 2 of 3

Surveyed on July 14, 15, 19-21, 23,
and August 6, 10, 2021
